ASBESTOS INVESTIGATION AND REMEDIAL OPTIONS ANALYSIS
KYMORE VILLAGE, MADHYA PRADESH, INDIA

ECO Project No.: 16452

October 2016

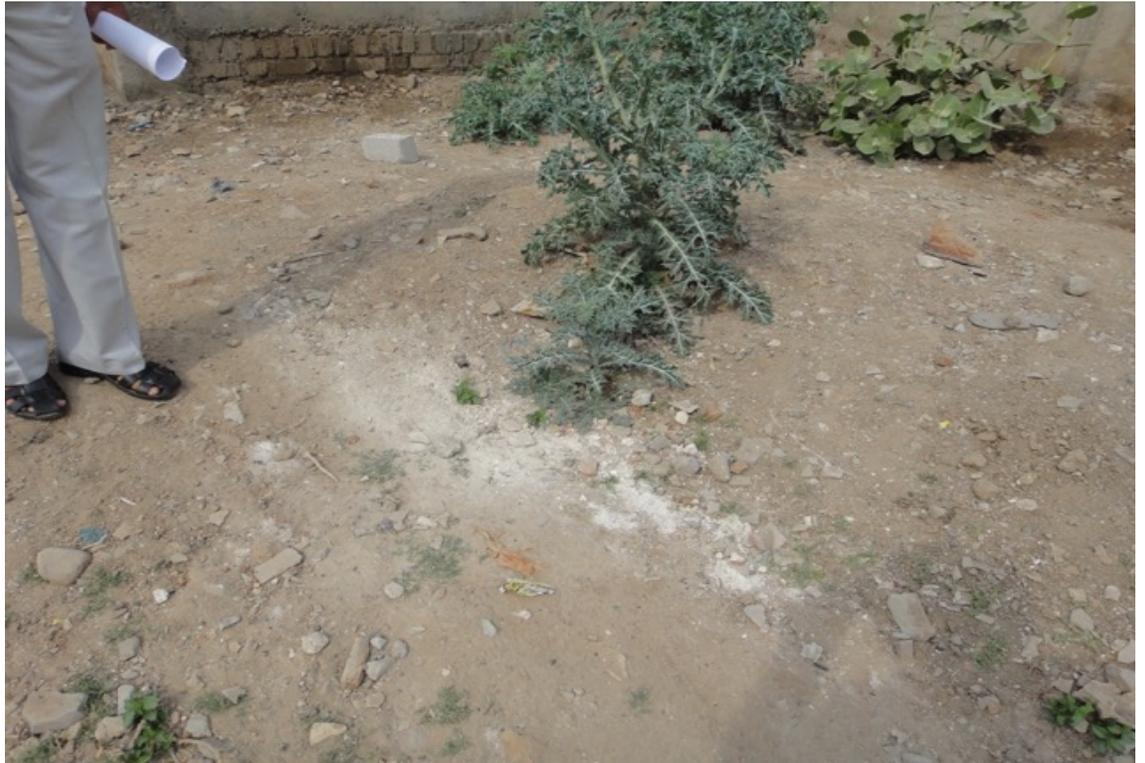
Friable Asbestos debris at surface near residences.

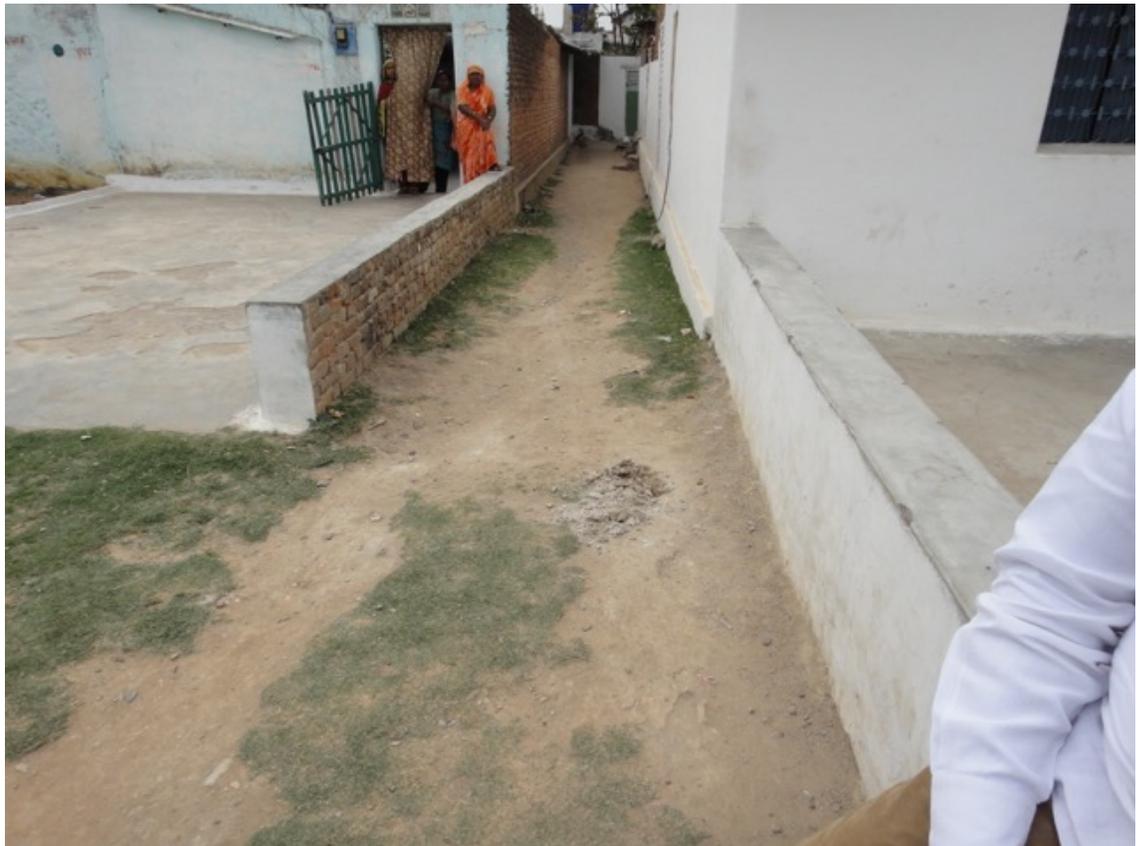
Photo No. 2.

Friable asbestos debris at surface between residences in Kymore village.

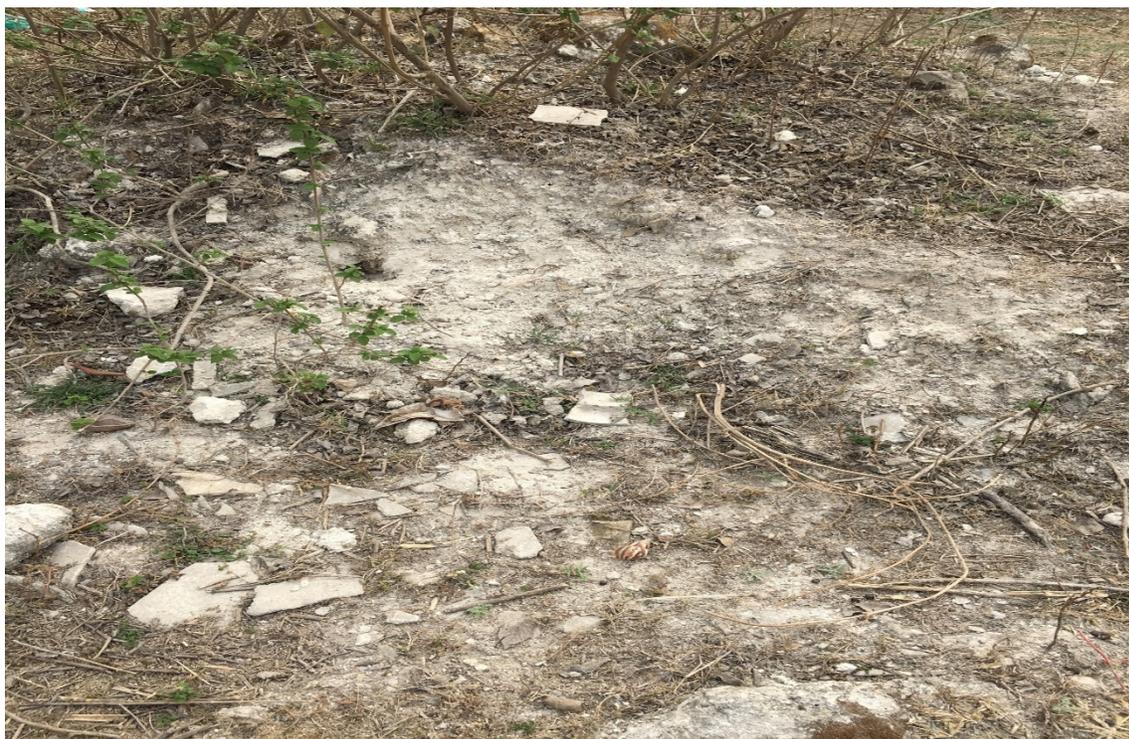
**Surficial Asbestos
Debris in hazardous
waste landfill**

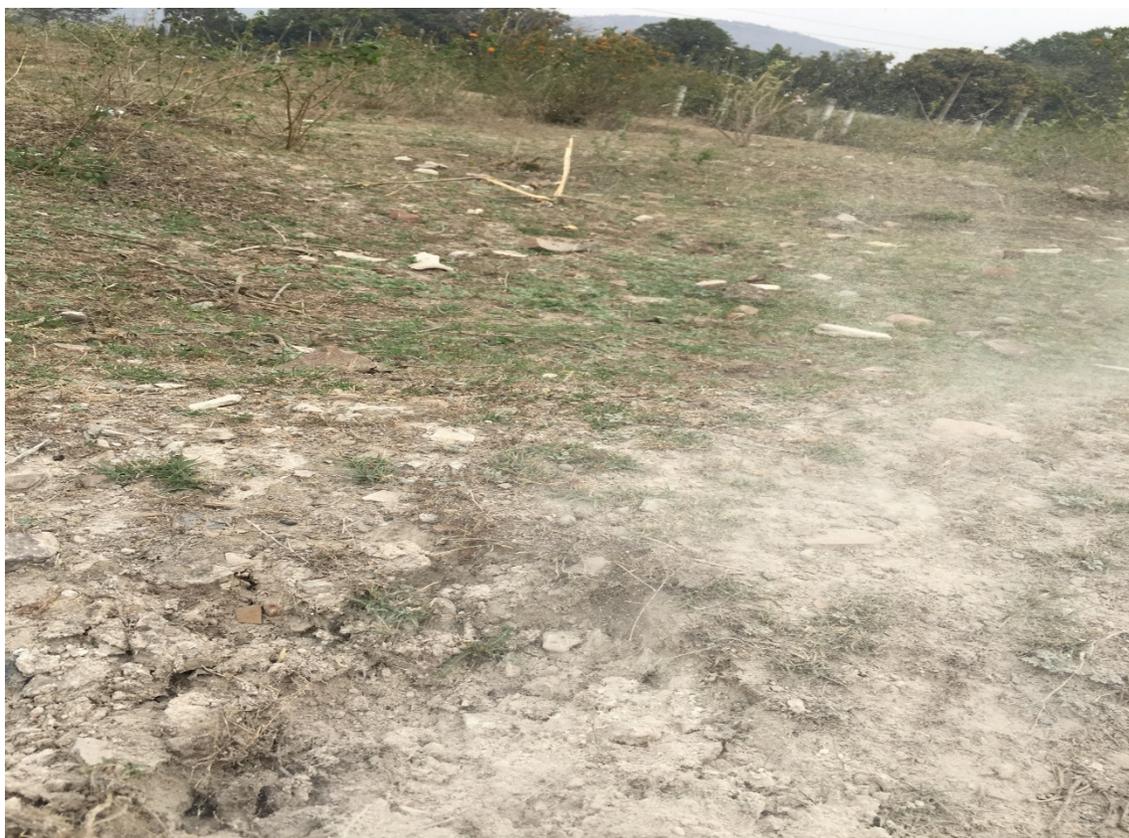
Photo No. 4.

**Surficial Debris in
fields near
residences.**

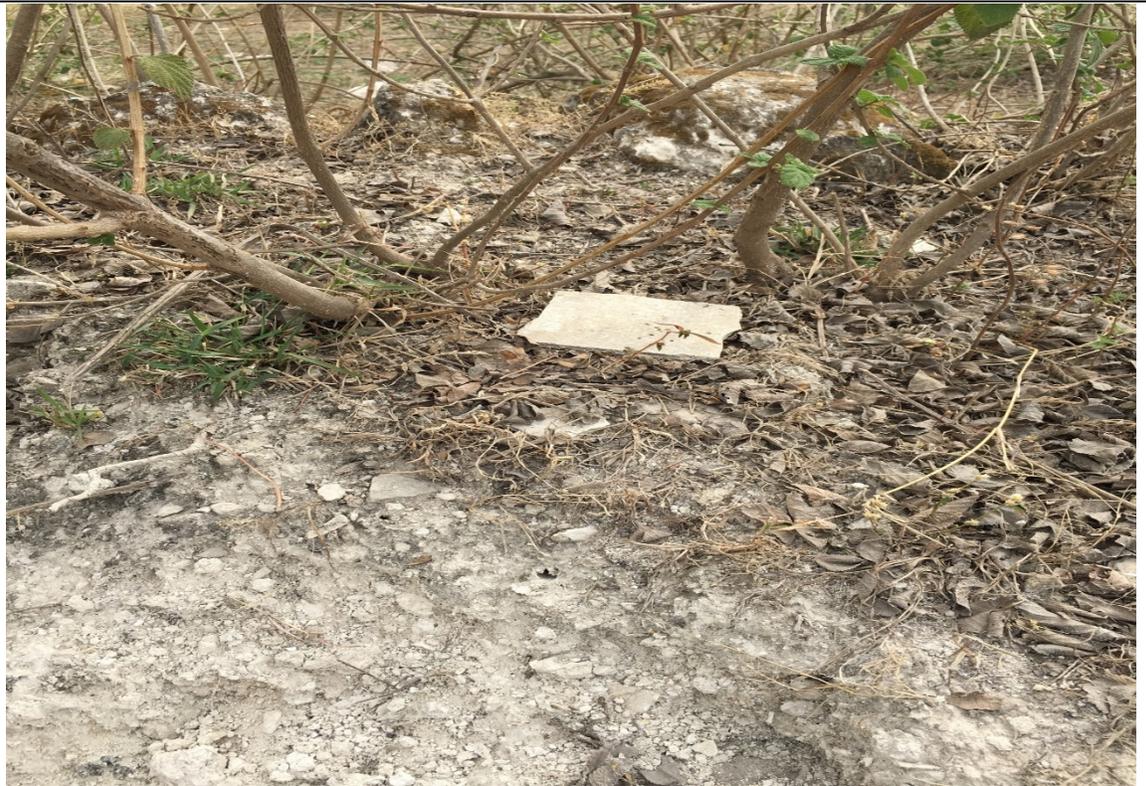
Poorly covered friable asbestos waste debris in landfill area.

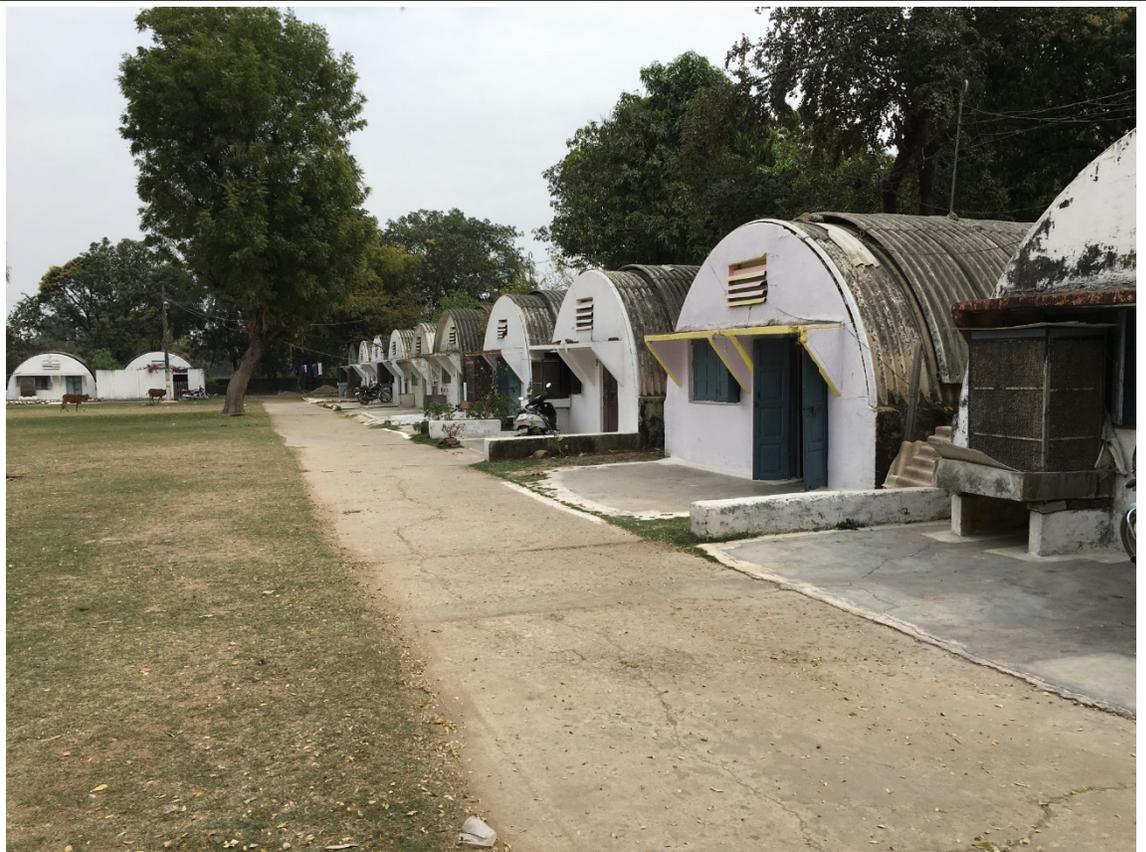
Photo No. 6.

Houses in Kymore (colonies) constructed with asbestos roofs, and partial walls. Asbestos in poor condition with signs of degradation.
